National Dam Inspection Program. Locust Lake Dam (NDS-ID-PA-00666, DER-ID-54-164) Delaware River Basin, Locust Creek, Schuylkill County, Pennsylvania. Phase I Inspection Report.

LOCUST LAKE DAM

PHASE I INSPECTION REPORT

SEPTEMBER 1978

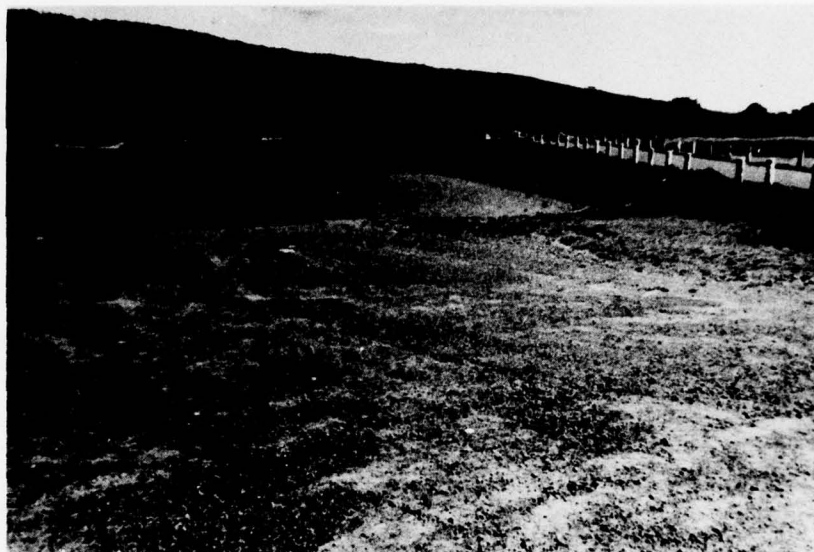
(2) There is some concern for the fact that the riprap on the upstream face does not extend to the top of the embankment. General practice is to provide upstream slope protection from the top of the dam to a safe distance below normal pool level. The unprotected portion of the upstream slope could be eroded by wave action during a flood condition.

(2) Upstream Slope. It was observed that the riprap does not extend to the dam crest. The detailed description and evaluation of the condition are in Paragraphs 3.1b. and 3.2a.(2), respectively.

A. Upstream Slope of Embankment.
View from Spillway Approach Channel.

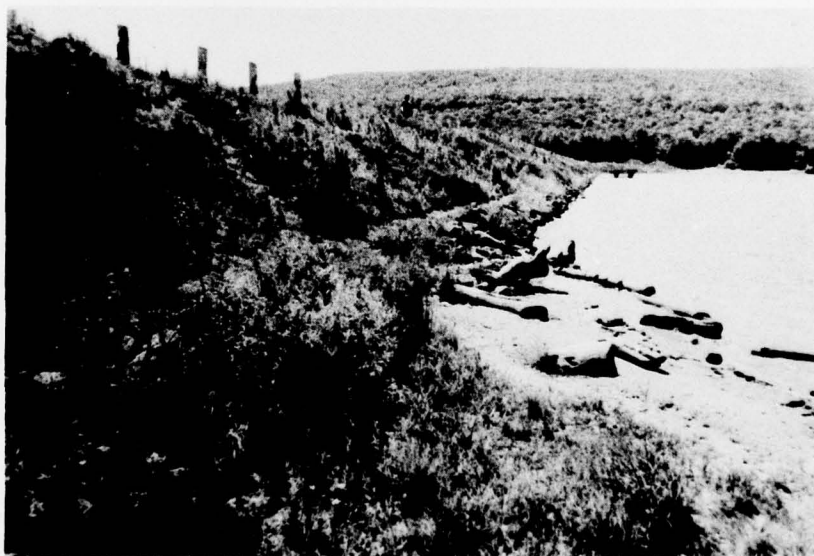
B. Upstream Slope of Embankment View from Left Abutment.

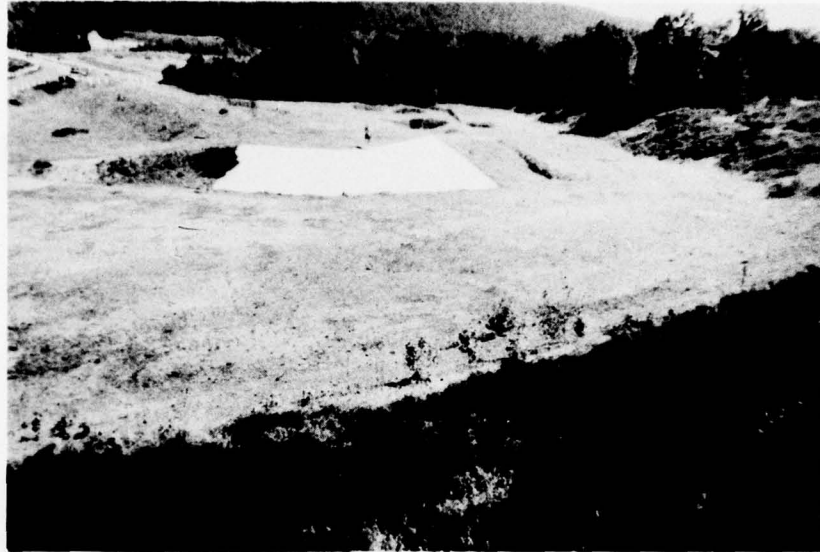
(1) Spillway. The spillway approach channel and outlet channel have a grass cover, and the sod is intact and is in good condition. No debris was present, and no abnormalities were observed.

I. Spillway Channel.
View from the Right Hillside.

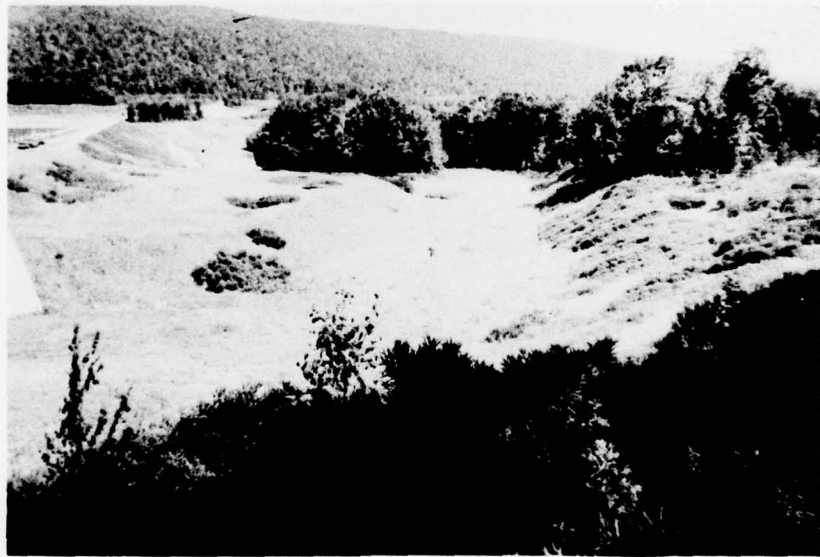
J. Spillway Outlet Channel.
View from the Right Hillside.

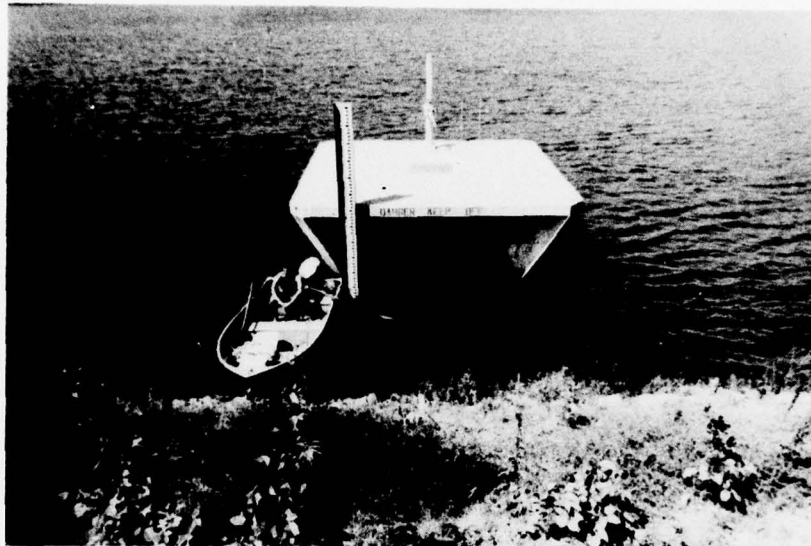
(2) Outlet Works. There is a fine crack about 18 inches long on top of the intake structure deck over the air vent at the southeast corner. There is another crack on the intake structure on the downstream face where the staff gage is bolted to the structure. The crack is about 2 feet long and about 1/8 inch wide. Both cracks are above normal pool elevation. The concrete of the outlet conduit is in very good condition. There is a fine crack in the

(2) There is slight concern for the two cracks on the intake structure. The cracks are relatively small, and the integrity of the intake structure is not in question. Because the air vent on the intake structure would be submerged at maximum pool level, the ultimate capacity of the outlet works is uncertain. In addition, debris could cause significant blockage of the intake structure and greatly reduce the outlet works capacity.

K. Intake Structure and Staff Gage.

(3) Visually monitor the two small cracks on the intake structure deck. Also, visually monitor the fine crack in the right wall of the outlet conduit. If changes are noted, take appropriate action.
